DAM SAFETY INSPECTION REPORT

**PLAINWELL DAM NUMBER 1
ID #00491
SE 1/4 SEC 24. T1N, R12W
KALAMAZOO RIVER
ALLEGAN COUNTY**

INSPECTION DATE: April 16, 2004

REPORT DATE: July 12, 2004

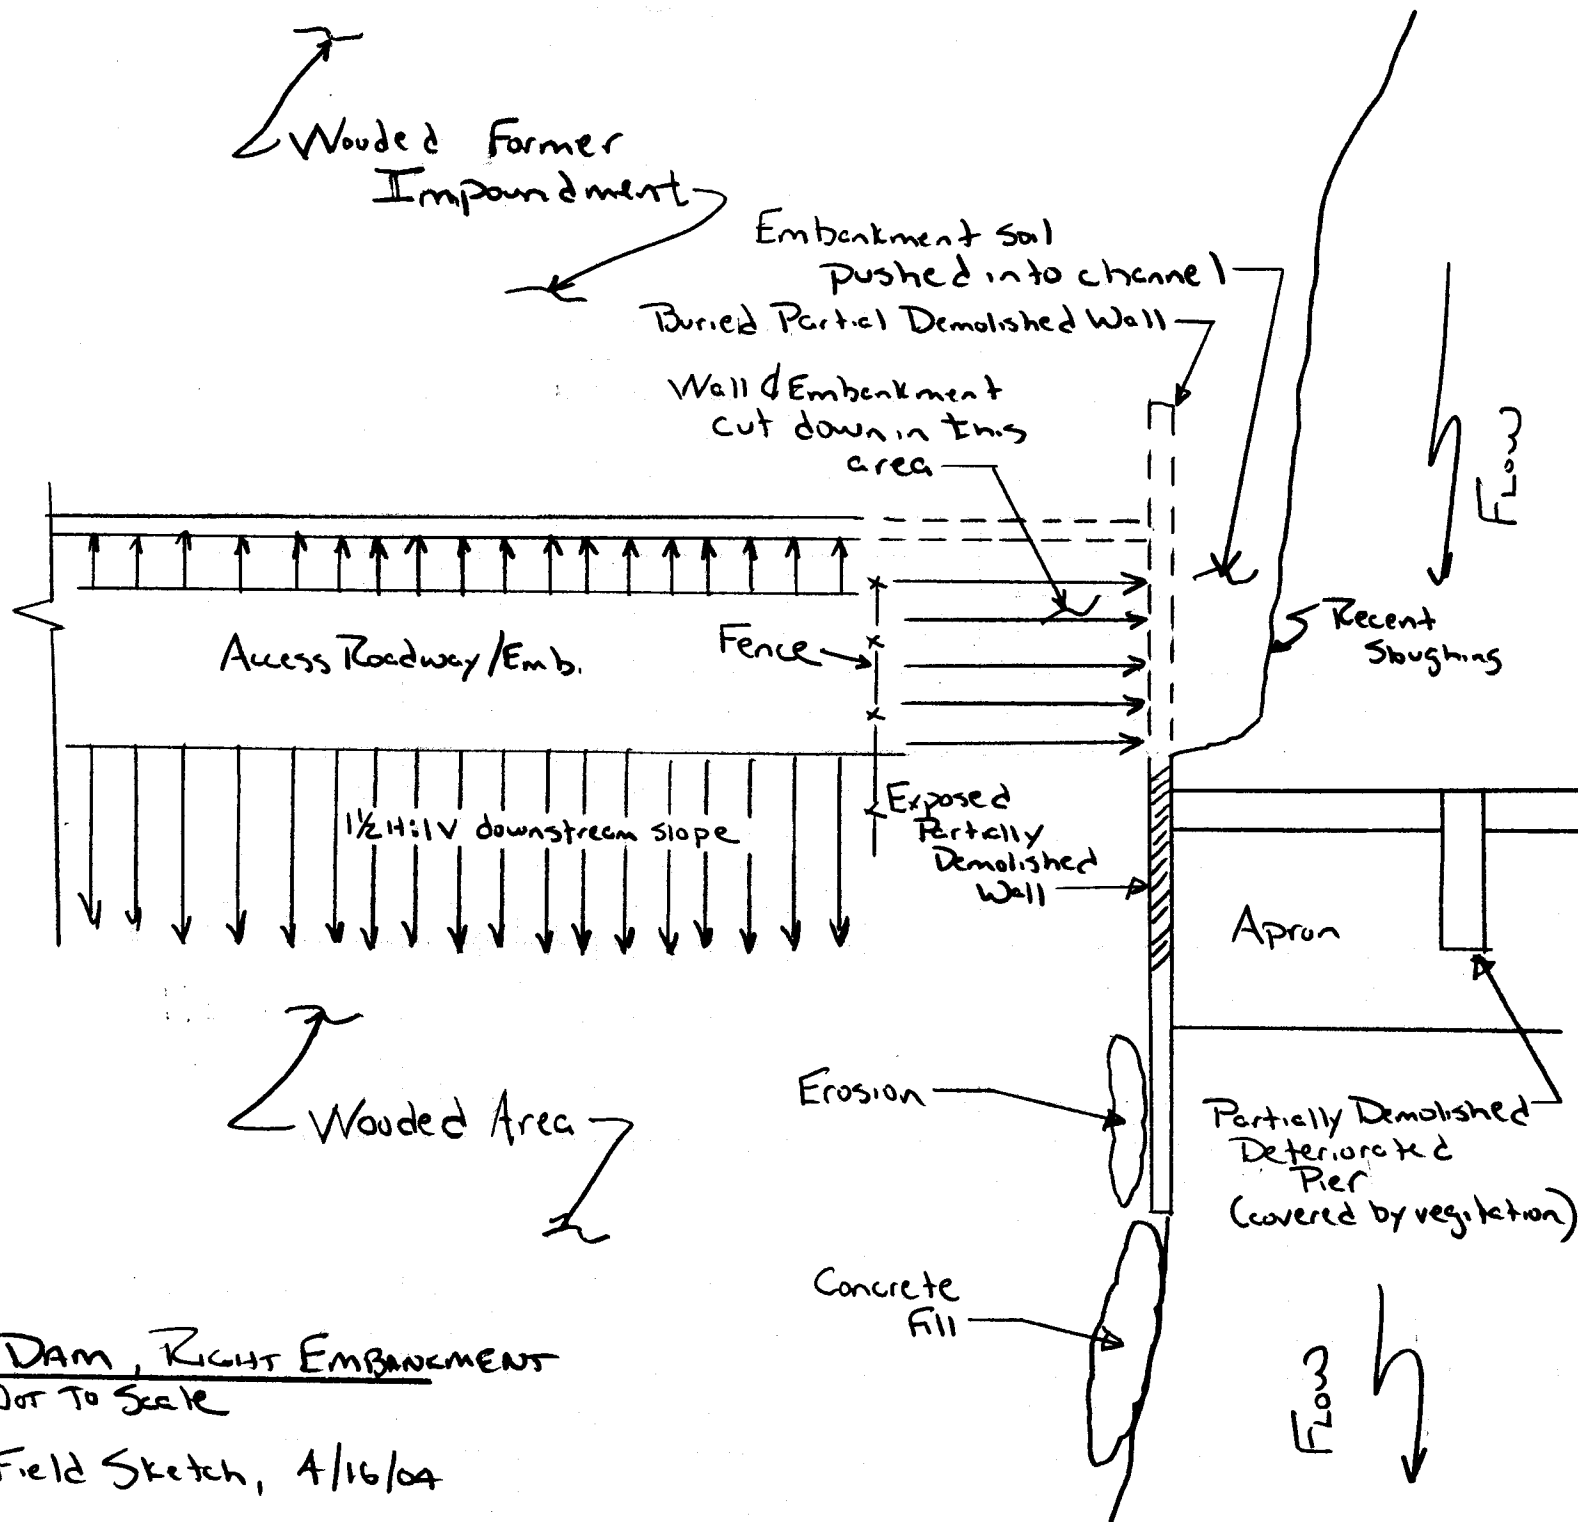
Inspection Field Sketch, 4/16/04

RAINWELL DAM, RIGHT EMBANKMENT
NOT TO SCALE

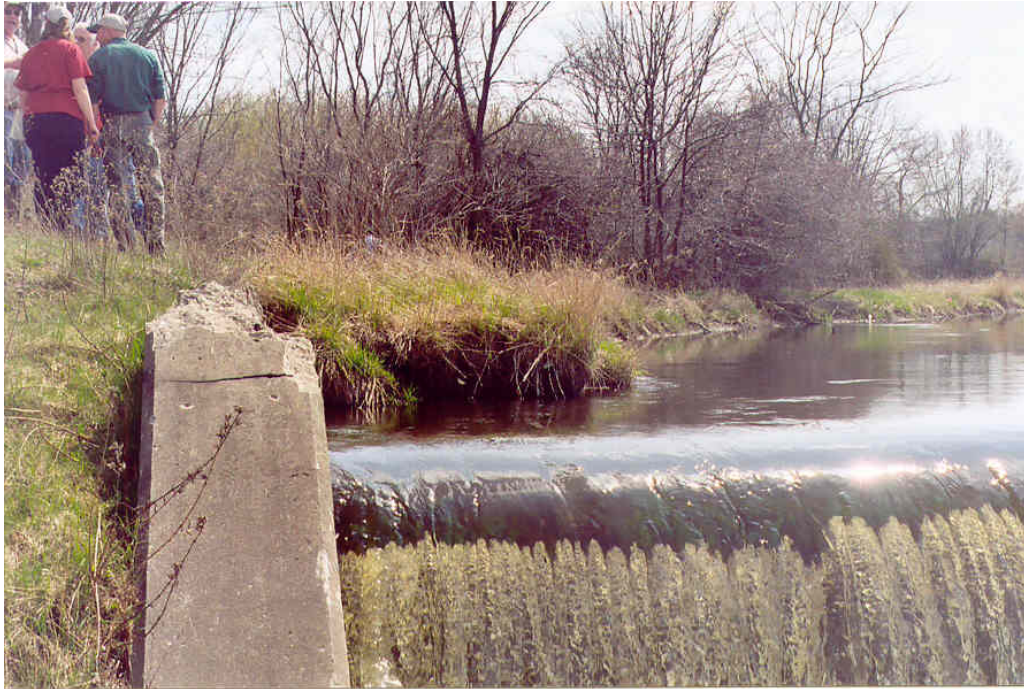
Right Training Wall with Sloughing Streambank behind

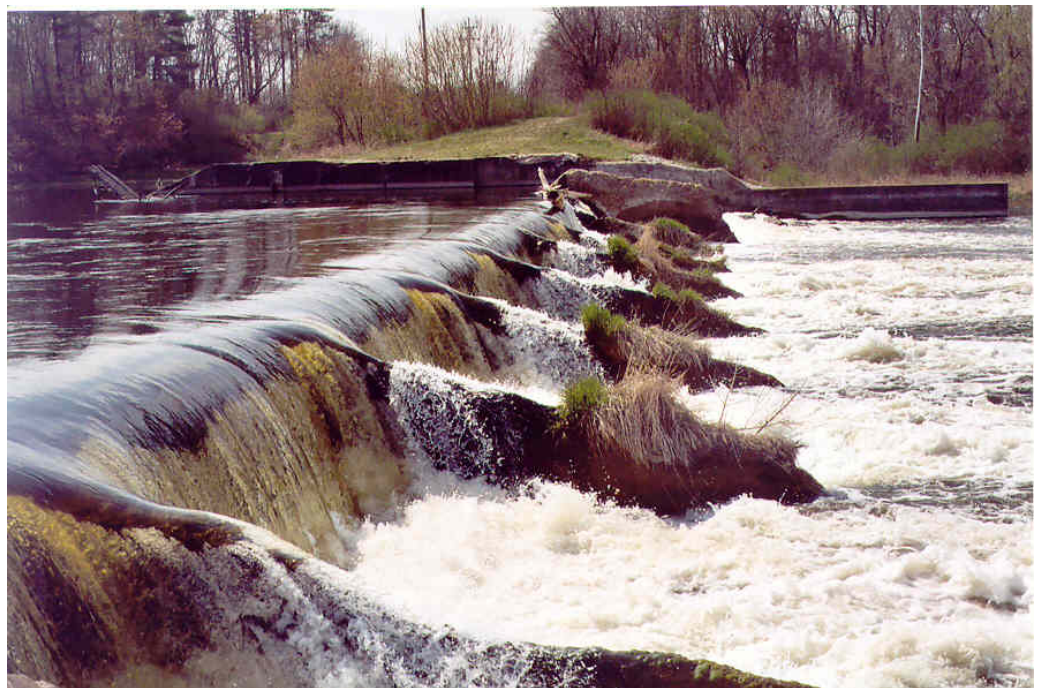
Spillway Piers

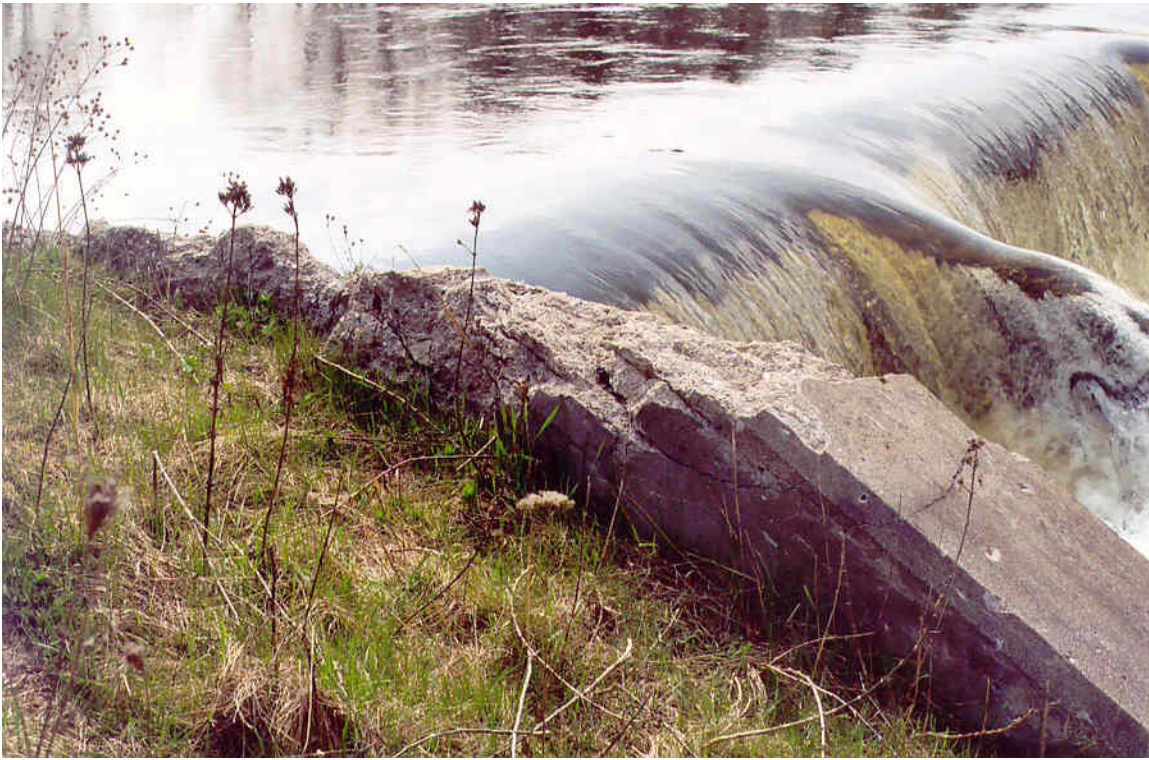
Partially Demolished Deteriorated Concrete at Right Training Wall

- Reconstruct the walls and embankment to enlarge the spillway capacity to meet current requirements. At the same time, the deteriorated concrete training walls at each side of the spillway and the interior piers should be repaired and surfaces protected against further deterioration.

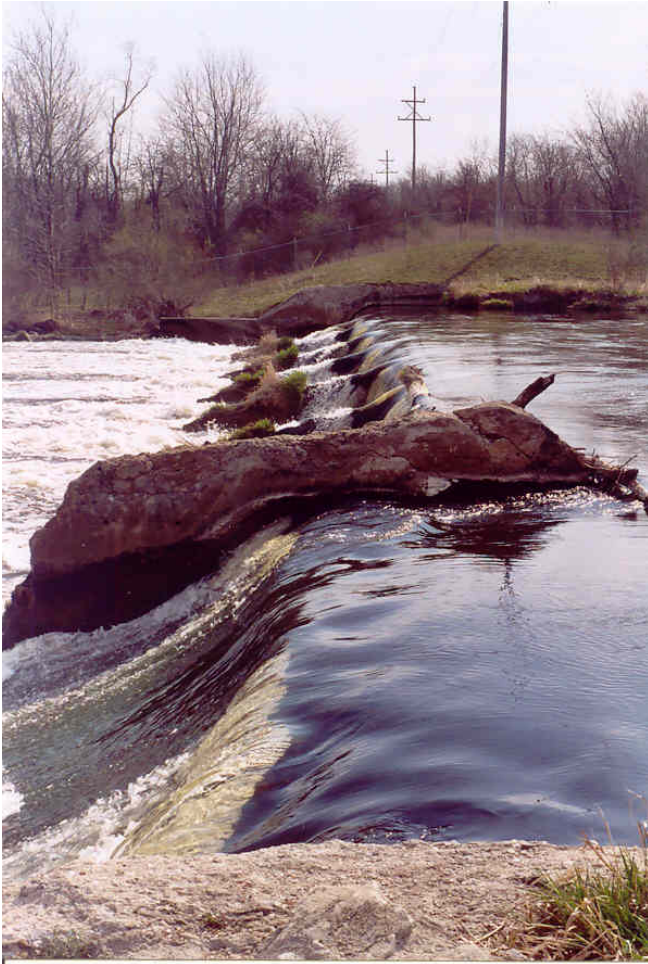
- The left spillway training wall is spalled in areas with two large cracks on the upstream end. While the piers where inaccessible and prevented detailed inspection, it was evident that these partially demolished structures were also deteriorated. The piers where also overgrown.

Deteriorated Piers

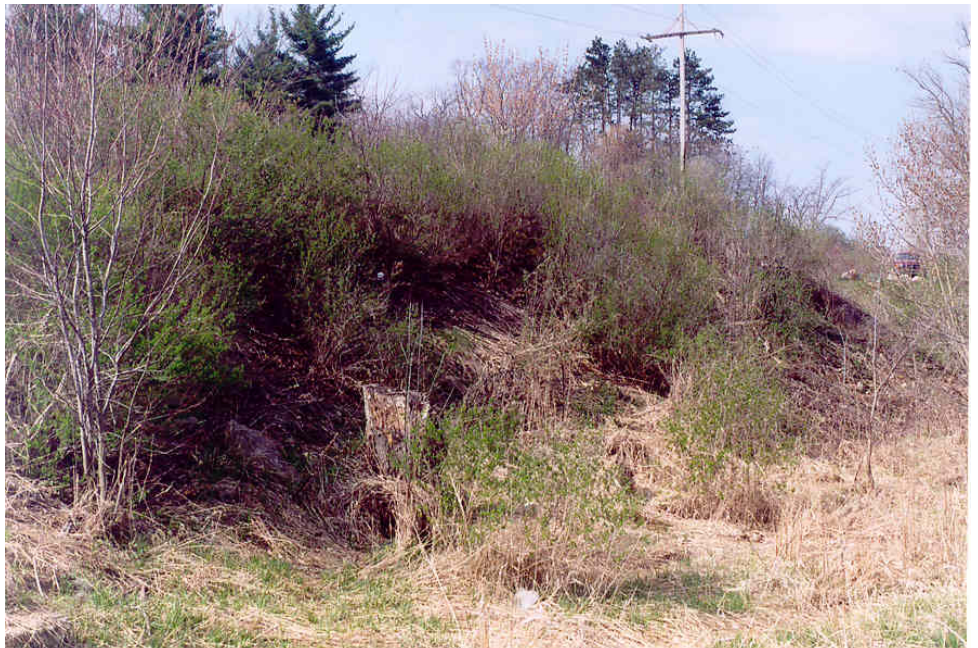
Stump and Brush on Downstream Embankment

- The entire left embankment should be re-graded, removing all trees and brush, and shaped with an even crest with upstream and downstream slopes no steeper than 3 horizontal to 1 vertical. Debris below the former powerhouse location should be excavated and replaced with low permeability fill which extend into the abutment to form an adequate cutoff to seepage. The upstream slope of the re-graded spillway should be protected by riprap with grass planted over the remainder of the spillway.
- The exposed right bank upstream of the spillway should be cutback and stabilized by riprap to avoid further loss of soil.
- Erosion on the downstream side of the right training wall should be filled and re-graded.
- Debris caught in the spillway and just upstream of the spillway should be removed.
- Cut brush on the left embankment near the former powerhouse should be removed.

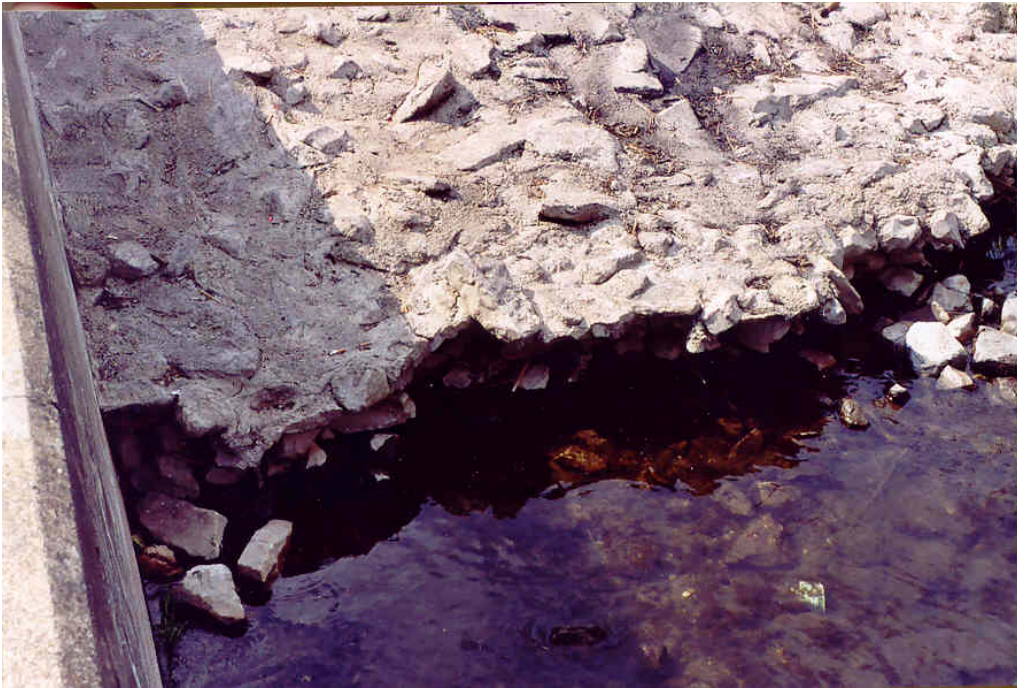
- The left embankment does not have adequate erosion protection on the upstream slope and erosion is also present on the downstream slope around the edges of the grouted riprap placed adjacent to the left training wall.

Eroded Grouted Riprap

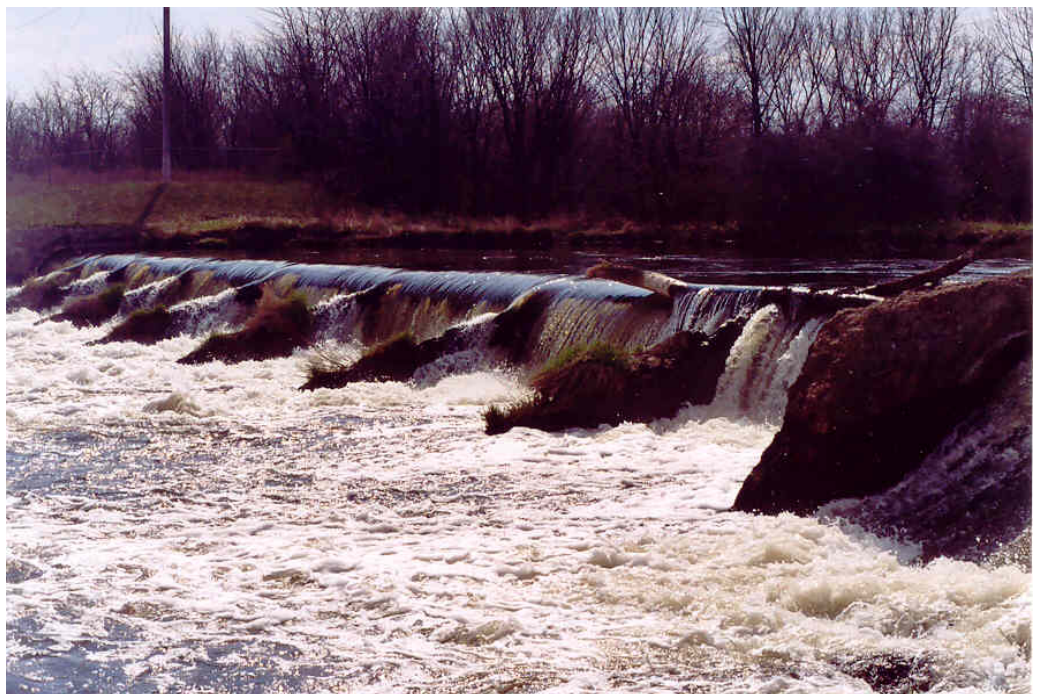
- Debris was caught on the spillway which included a large log. A timber cribbing mat was also caught on something, possibly an old intake, just upstream of the spillway.

Deteriorated Piers with Vegetation and Log caught on Spillway

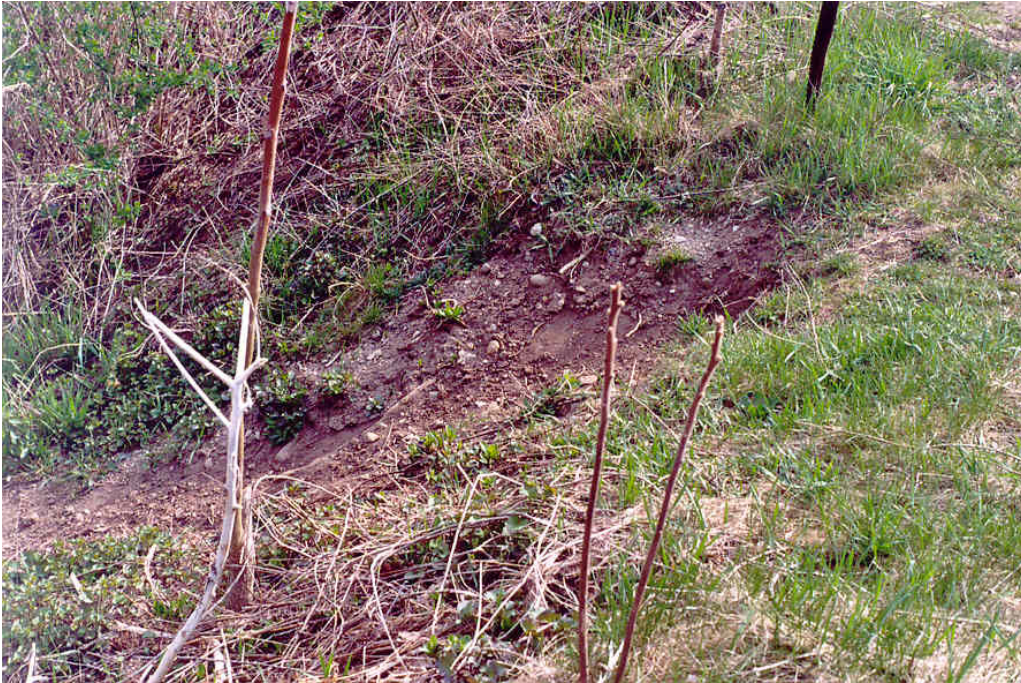
Erosion Path on Downstream Slope

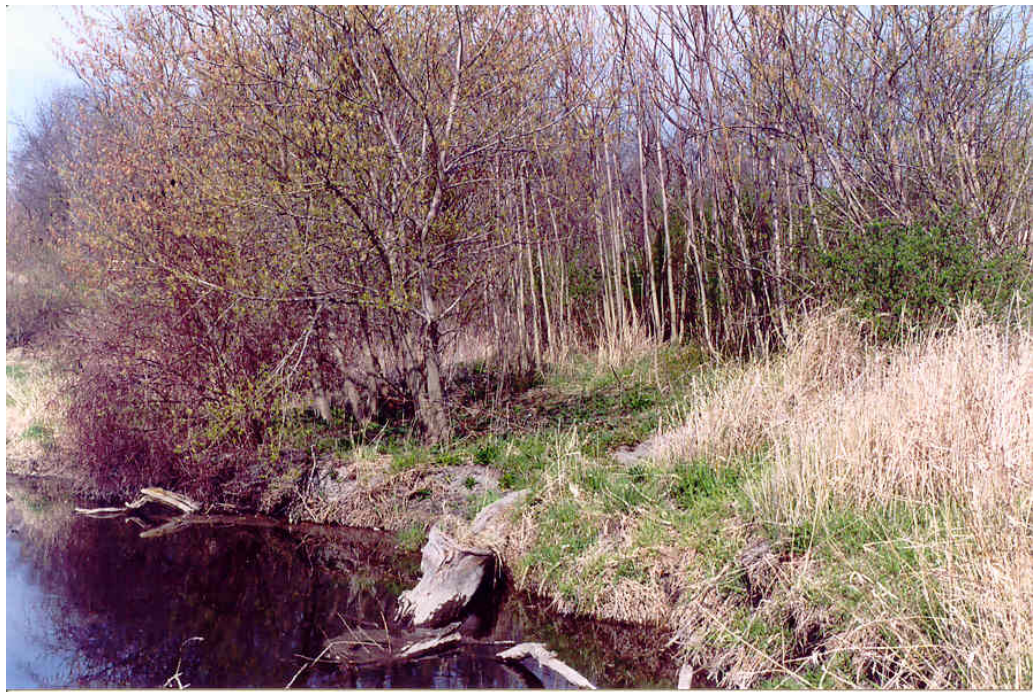
- In general, the left embankment is very uneven with a low area at the former powerhouse, rising to a high area in the vicinity of the former island and then dropping back down to a cut slope adjacent to the left training wall of the spillway. The embankment generally appears stable other than sloughing on the upstream slope near the training wall. No lateral movement or tipping of the training walls was observed. The long embankment on the right side of the dam is reportedly no longer necessary due to the lower spillway height, however it too appears generally stable with no movement to the concrete wall which forms the upstream face along much of the embankment.
- The left embankment of the dam has areas overgrown by brush and trees.
- The upstream slope of the embankment near the left training wall is very steep and is eroded at the toe.

Ungraded, Sloughing Upstream Slope with no Erosion Protection

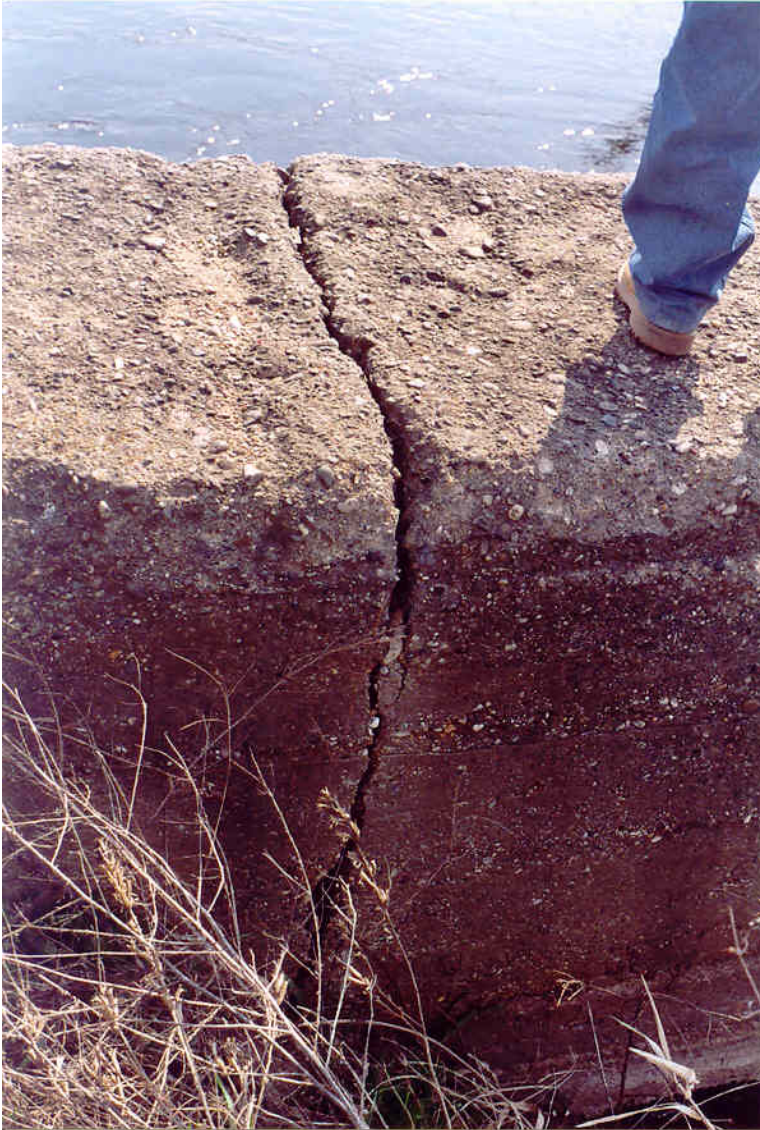
Crack in Left Training Wall
